Automated Excess Air Control in Fired Heaters - Eliminating Burner Air Register Jackshaft/ Linkage Arm Assembly Reliability Issues with BUSA Compensator Retrofit

Cortney Hall, ExxonMobil Baytown Fired Equipment Engineer

Walter Gull, Birwelco USA President & General Manager (A BIH Group Company)

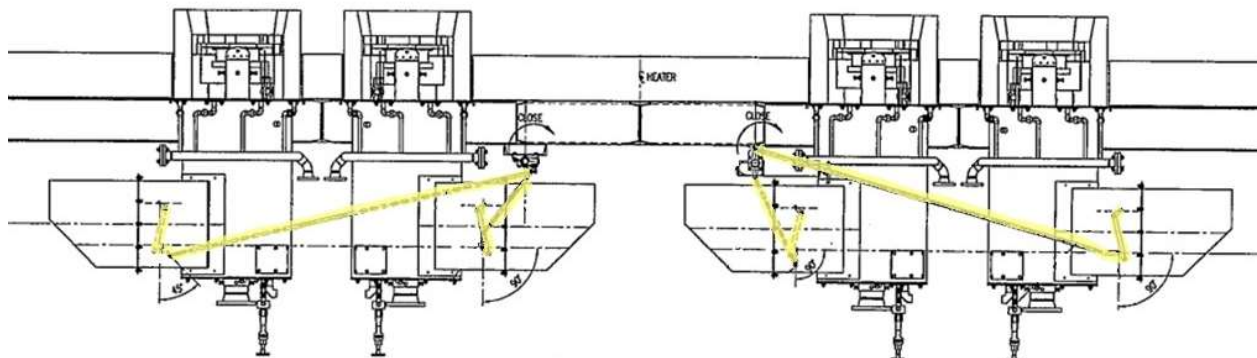
Figure 2: Fired Heater burner with jackshaft linkage/ arm connection assembly.

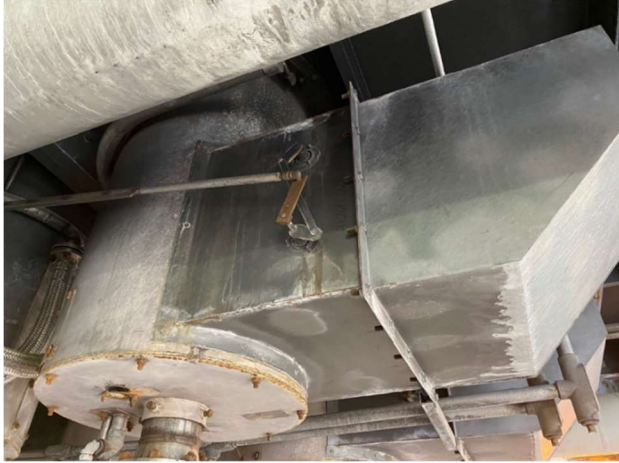
Figure 3: Fired Heater burner with jackshaft lever rod connection to burner register assembly shown.

often prone to reliability vulnerabilities associated with the multiple jackshaft rods used to join multiple burner air registers to a single actuator drive shaft. This approach to automation is shown in figure 3 with a jackshaft linkage/arm assembly attached to the burner register shaft. Assembly alignment and reliability issues are two major problems with Jackshaft linkage/ arms assemblies. Overtime, these systems are prone to alignment issues associated with shifting, sagging, flexing, and bowing of the linkage arms as well as loosening bolts and increased play (hysteresis) at the linkages knuckles. This deflection/ play is often made worse when the burner registers themselves become difficult to open/ close or freeze in position. The

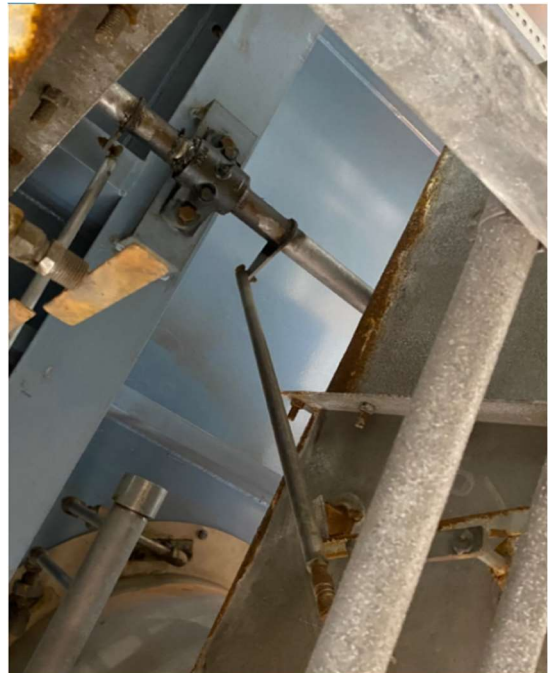
Figure 4: Fired Heater burner with jackshaft rod connection to actuator drive shaft shown.

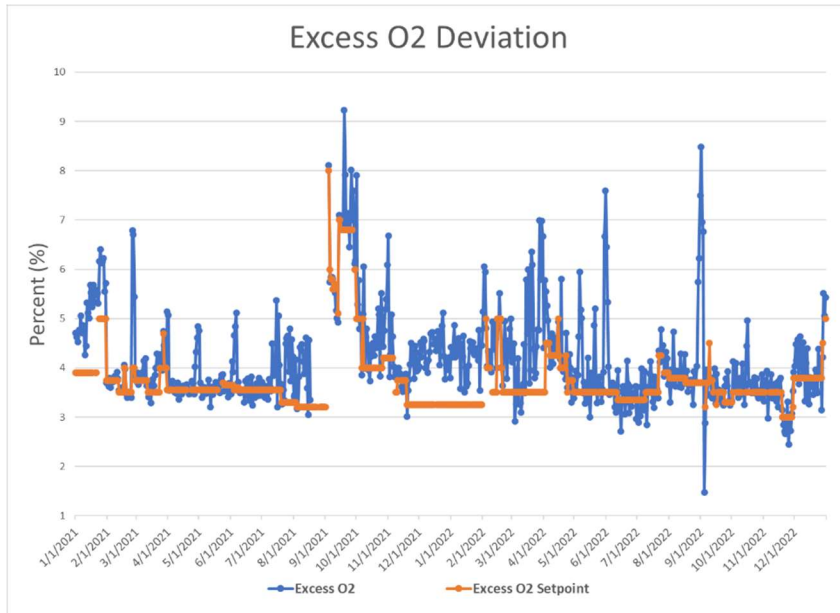
Figure 5: Excess O₂ vs Setpoint for 2021 and 2022.

the energy loss associated with inefficient operation for the heater rose steadily from 4 MMBTU/hr. to a consistent range of 12 to 20 MMBTU/hr. due to air register reliability challenges. This led to nearly 1 million dollars in losses due to excessive fuel usage for this heater.

control of the burner air registers leaving the system incapable of consistently maintaining O₂ targets. In addition, the team was forced to operate the heater with a significant O₂ cushion to mitigate operational concerns associated with reaching insufficient air due to frequent variation in firing rate and fuel composition. Figure 5 highlights the regular challenges experienced with meeting O₂ targets and maintaining setpoints due to corrosion, seizing, and regular operability challenges. From October 2021,

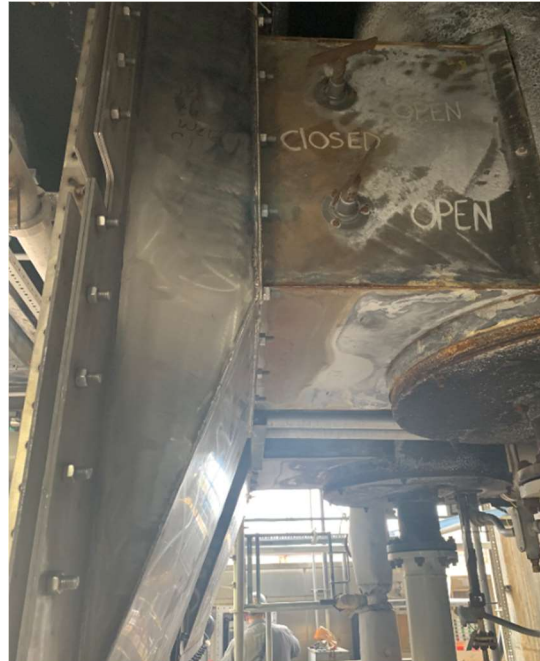
Figure 6: Birwelco USA Burner Compensator fit up to existing burners.

Birwelco USA Burner Compensator technology offered several benefits compared to the previously discussed approaches that relied on the use of the existing burner registers. These benefits include update of actuator technology, elimination of rotating linkage connections, and ability to install the design while the heater remains in operation. The BUSA design as configured for this heater, consisted of four new REXA Electraulic linear actuators as show in figure 7. These actuators offer high response time, accuracy, and the travel repeatability required for the compensators to provide optimum O₂ control. Being a closed system, the hydraulics driven by an electric motor, electraulic actuators do not suffer from the performance and maintenance issues associated with instrument air. As with dampers, the Compensator system can be designed to fail last position or to fail in other modes based on owners control philosophy. Elimination of the jackshaft linkage/ arm assembly improves system reliability by eliminating the multiple failure points of the system. Most importantly, the simple bolt on design allowed BUSA to design, fabricate, test functionality, install and calibrate all 24 burner compensators without interrupting operation. This is a critical benefit allowing the team to capture the value of heater performance improvement while avoiding margin loss and associated outage costs.

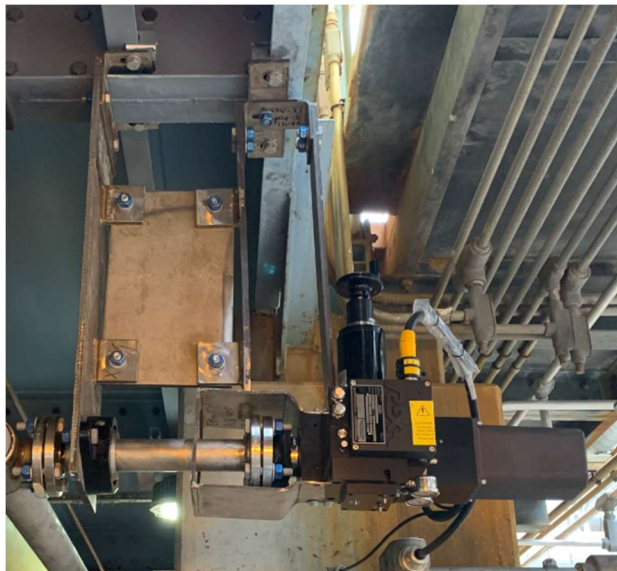
Figure 7: REXA Electraulic linear actuator driving Birwelco USA Burner Compensator assembly thrust bar.

Additionally, all 24 burner compensators can be controlled simultaneously with four electraulic linear actuators. The installation was designed to have one actuator per row of burners firmly attached to a thrust bar which in turn, is pinned directly to each compensator sliding plate assembly. The compensators

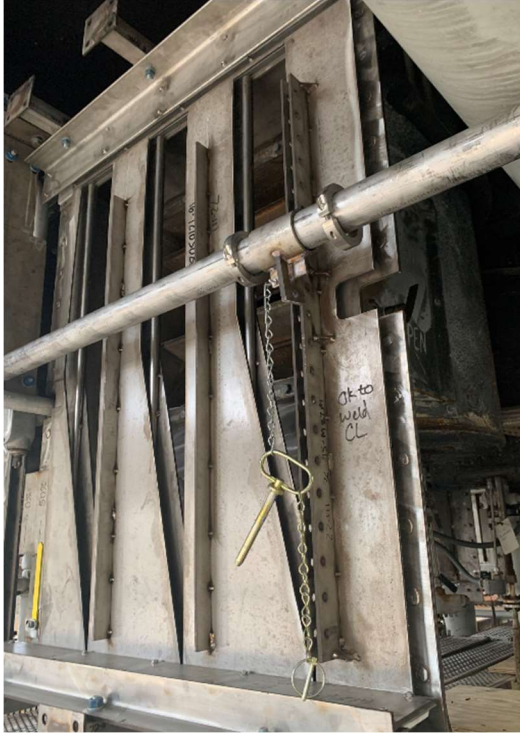
Figure 8: Birwelco USA Burner Compensator sliding plate, thrust bar, and removable pin (wind break removed).

are designed around the existing burner design, ensuring that any additional pressure drop at the intake of the burner is minimal so as not to impact the burners performance when firing at 100% capacity. The customized air intake, shown in figure 8, is designed to achieve a significantly more linear correlation between position and associated pressure drop. Openings are calibrated in size and shape to allow uniform consistent adjustment of the air entering every burner. The design of each individual compensator is compact, in many cases replacing the existing burner scoop intake duct and extending no lower than the existing burners. Unlike the existing jackshafts, a ridged thrust bar drives one row of the compensators. Each thrust bar runs the length of the heater, and the attachment between the thrust bar and each

compensator is a removable pin. This allows the detachment of an individual compensator from the rest by operations personnel if a burner needs to be taken out of service or isolated for maintenance. With the compensator 100% closed, the assembly is designed to minimize leakage and offer good shut off comparable to the existing register design. The removable pin is chained to the compensator to allow operators to easily disengage an individual compensator, without misplacement.

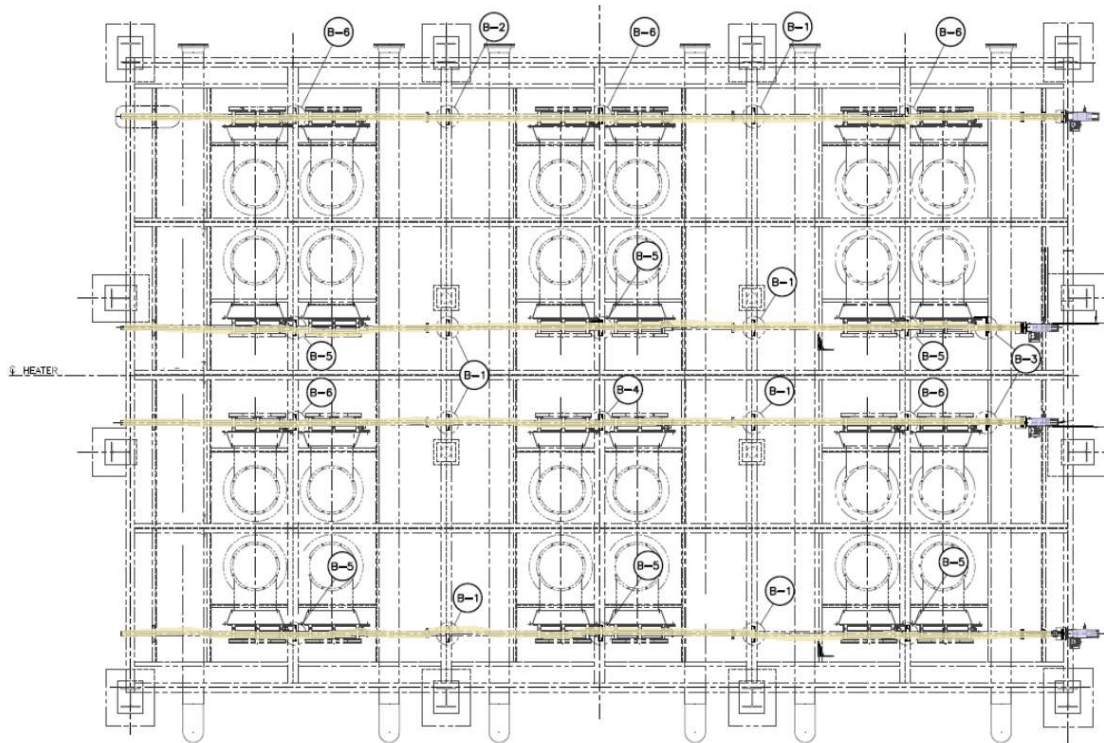
Figure 9: Splitter Reboiler Furnace with Birwelco USA Burner Compensator assembly for 24 burners.
